## Using Dry Ice for Spray-Paint Removal on Weathering Steel

MARY B. BRUSH

## Case Study: The Time Life Building

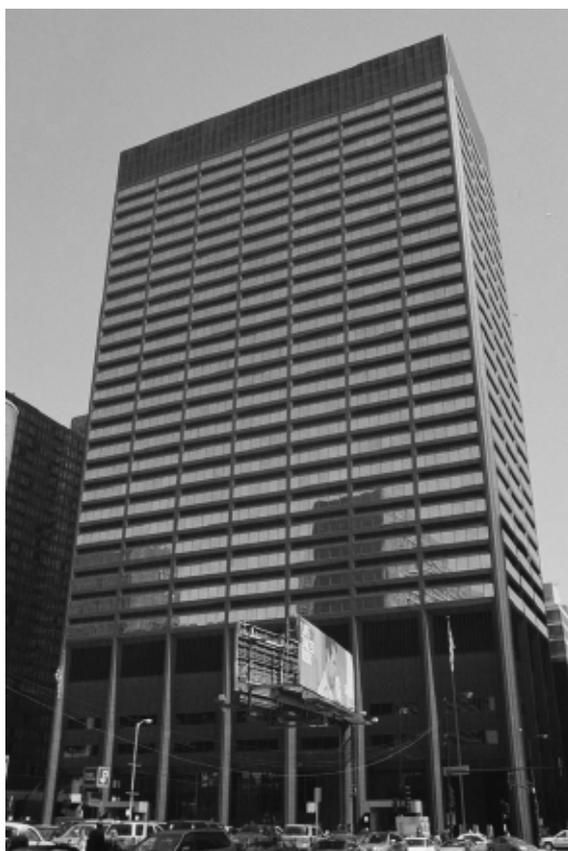
**Fig. 1.**  
*The Time Life Building,  
Chicago, Ill., Harry Weese  
Architects, 1968. All pho-  
tographs by the author.*

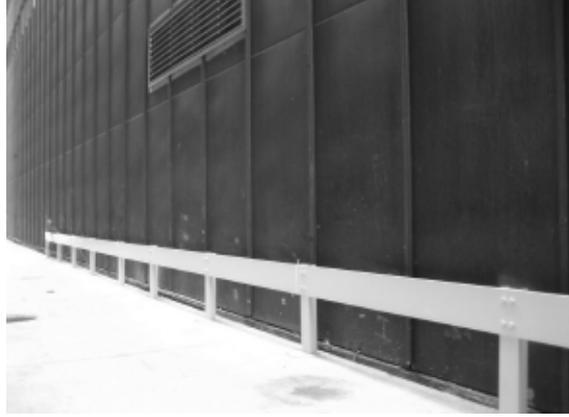
**Fig. 2.**  
*The alley facade of the Time Life Building before treatment. Note the areas of spray paint above and below the guard rail.*

The 2007 restoration work was very limited in nature. The building management was concerned about the material condition and aesthetics of the weathering steel after it suffered from an unwanted application of spray paint by an adjacent construction-site crew (the spray paint was located on an alley wall adjacent to a neighboring construction site). The spray paint was primarily either a construction-grade bright orange or green color. Markers were then used to write dimensions and numerical notations on top of the spray paint. The wall was further compromised by the effects of de-icing salts and water spray from vehicles. The goal was to remove the writing and spray paint without affecting the weathering-steel patina (Figs. 2 through 4).

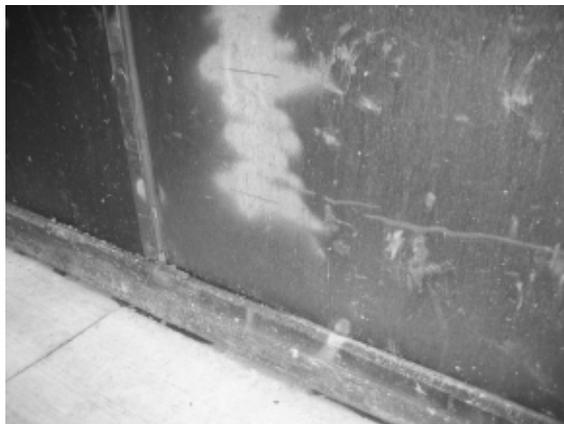
**Fig. 3.**  
*The contaminants on the weathering steel of the Time Life Building shown here include spray paint, de-icing salts, and corrosion runoff from the building. The concrete base of the facade below the steel is also discolored.*

The test locations also included areas affected by de-icing salts; these areas showed a minor improvement, and the mortar and concrete splashes were completely removed. The deterioration and discoloration resulting from the de-icing salts were considered less important, because it was seen as a recurring condition beyond the control of the building management. The spray paint and the mortar and concrete
